Animas River Mine Water Spill

Briefing Report

For the Radioactive and Hazardous Materials Committee
September 25, 2015

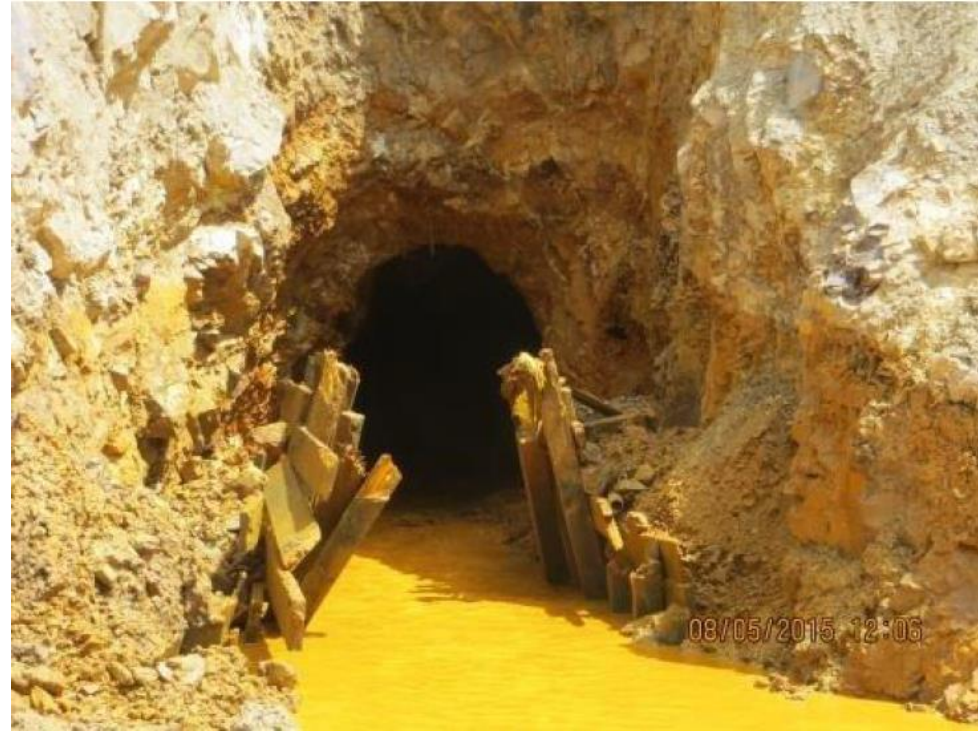
August 5, 2015 Blowout

- The Gold King Mine near Silverton, CO was operated from the late 1800's into the 1930s.
- Abandoned mine workings have long been a source of acid rock drainage (ARD).
- Bulkheads installed to plug up ARD caused the impoundment of mine water in the abandoned workings, and a 1,000 foot rise in the water table.
- EPA work crew digging into a collapsed mine tunnel triggered the blowout of impounded water.

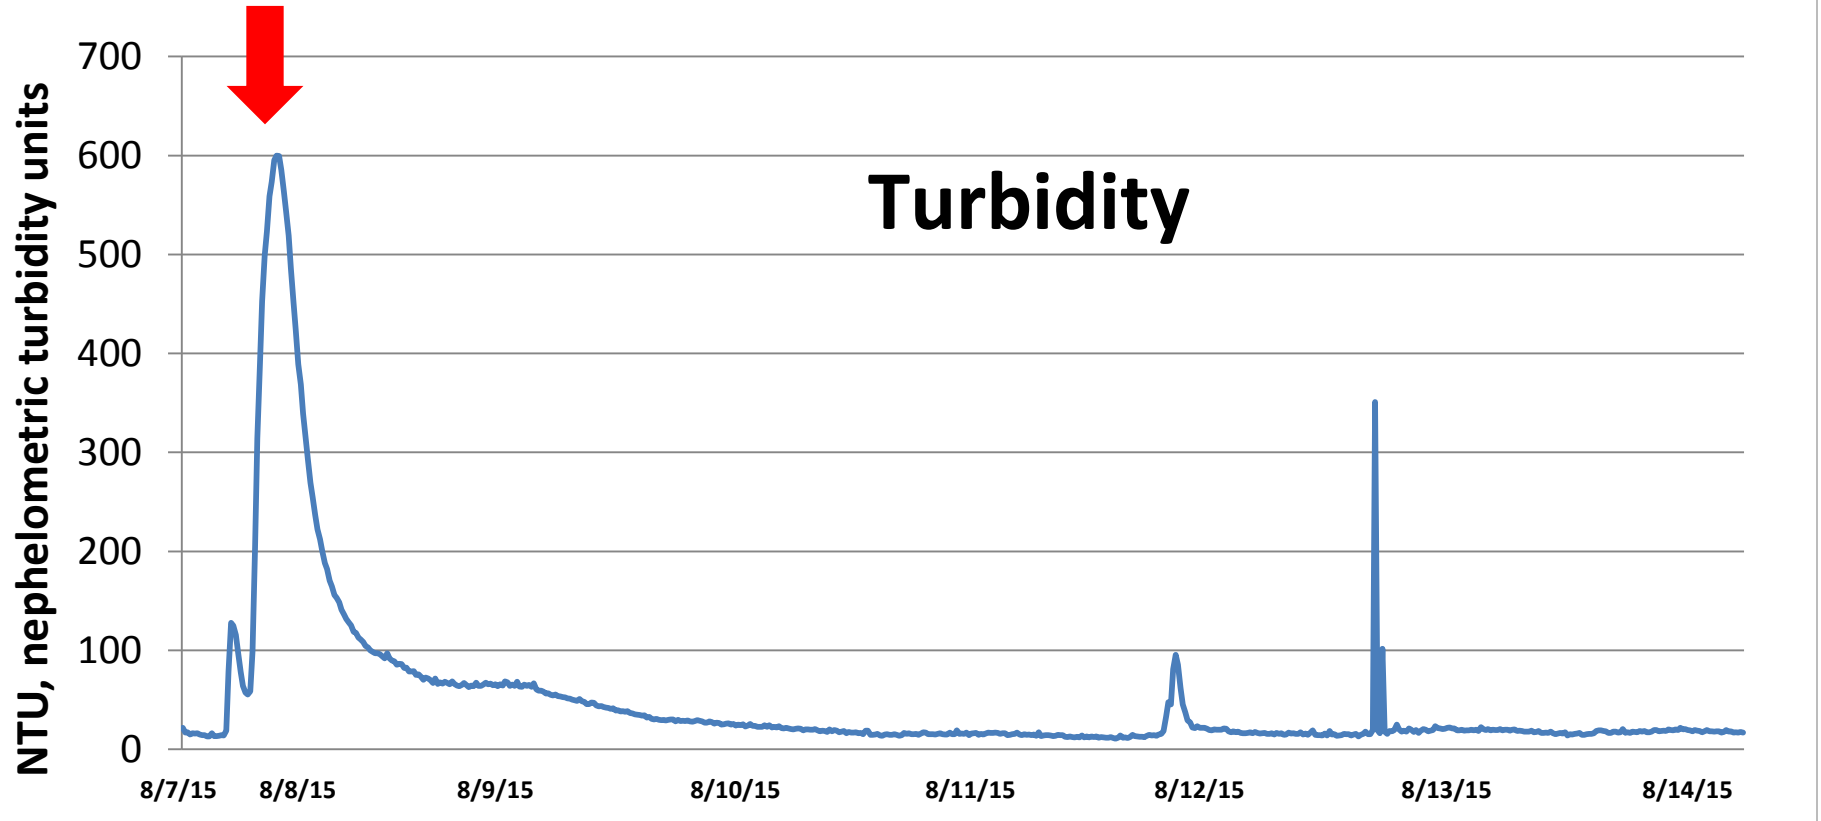
Plume Arrives in NM

Animas River near Aztec, NM

(above Estes Arroyo, NMED data)

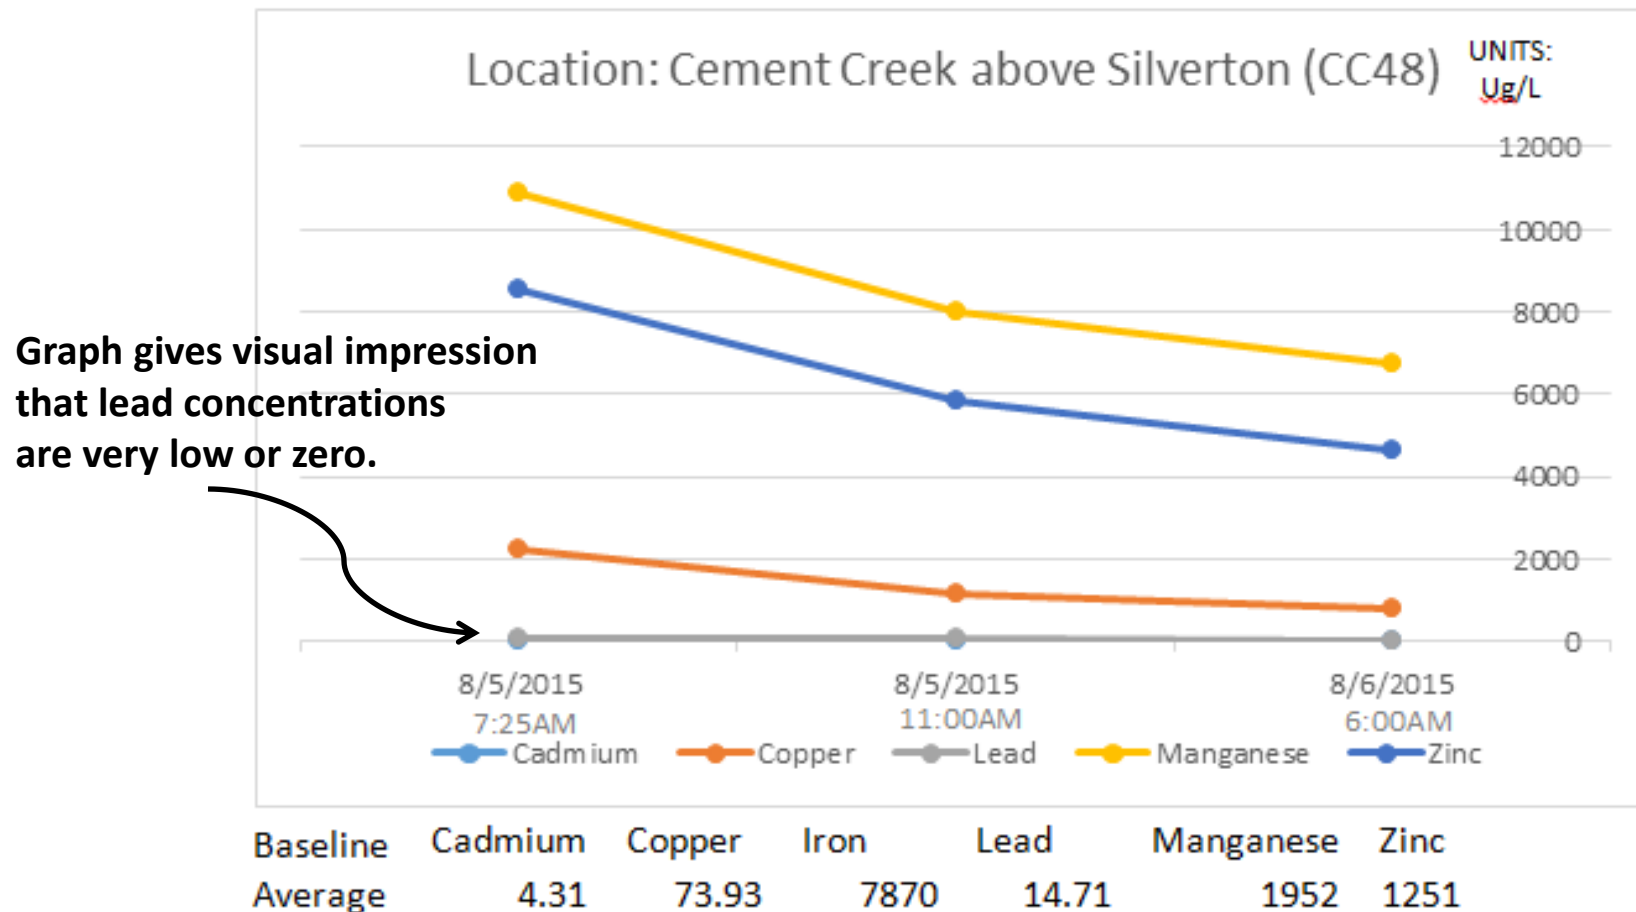
EPA Graph of Dissolved Metals in Surface Water

(Provided by EPA to NMED on August 7, 2015)

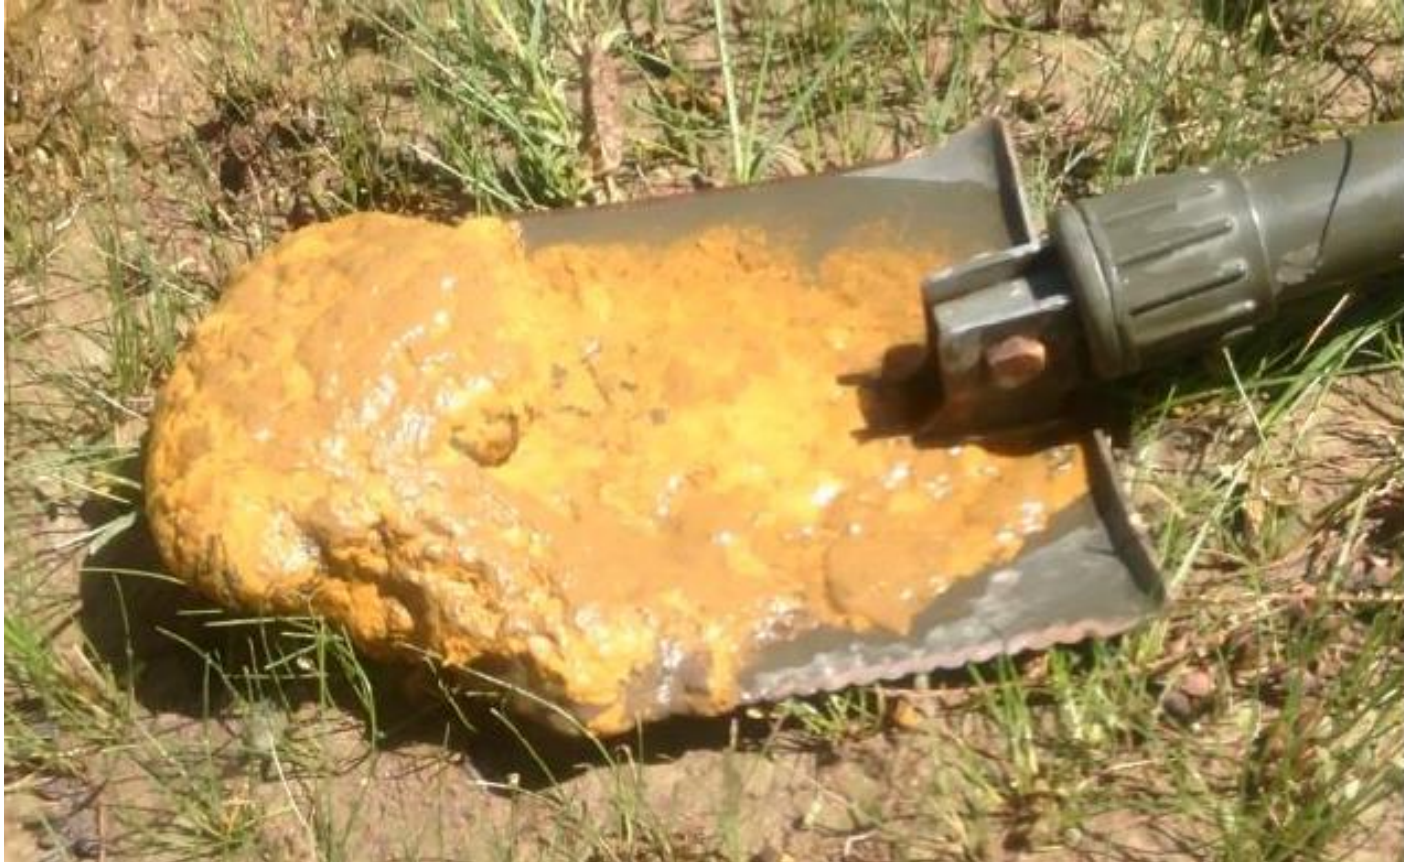
**Spill sediment deposited underwater in the
Animas River in N.M.**

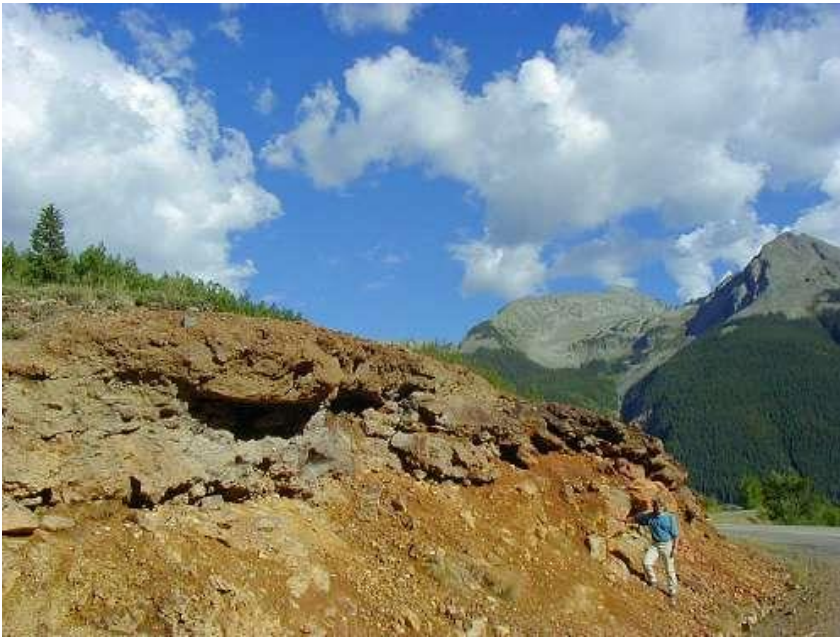
Ferricrete

Iron and other metals in ARD can precipitate and cement near-surface sediments into ferricrete. Geologic deposits of ferricrete in Cement Creek demonstrate that ARD has been occurring in this mineralized area long before mining began in the late 19th century.

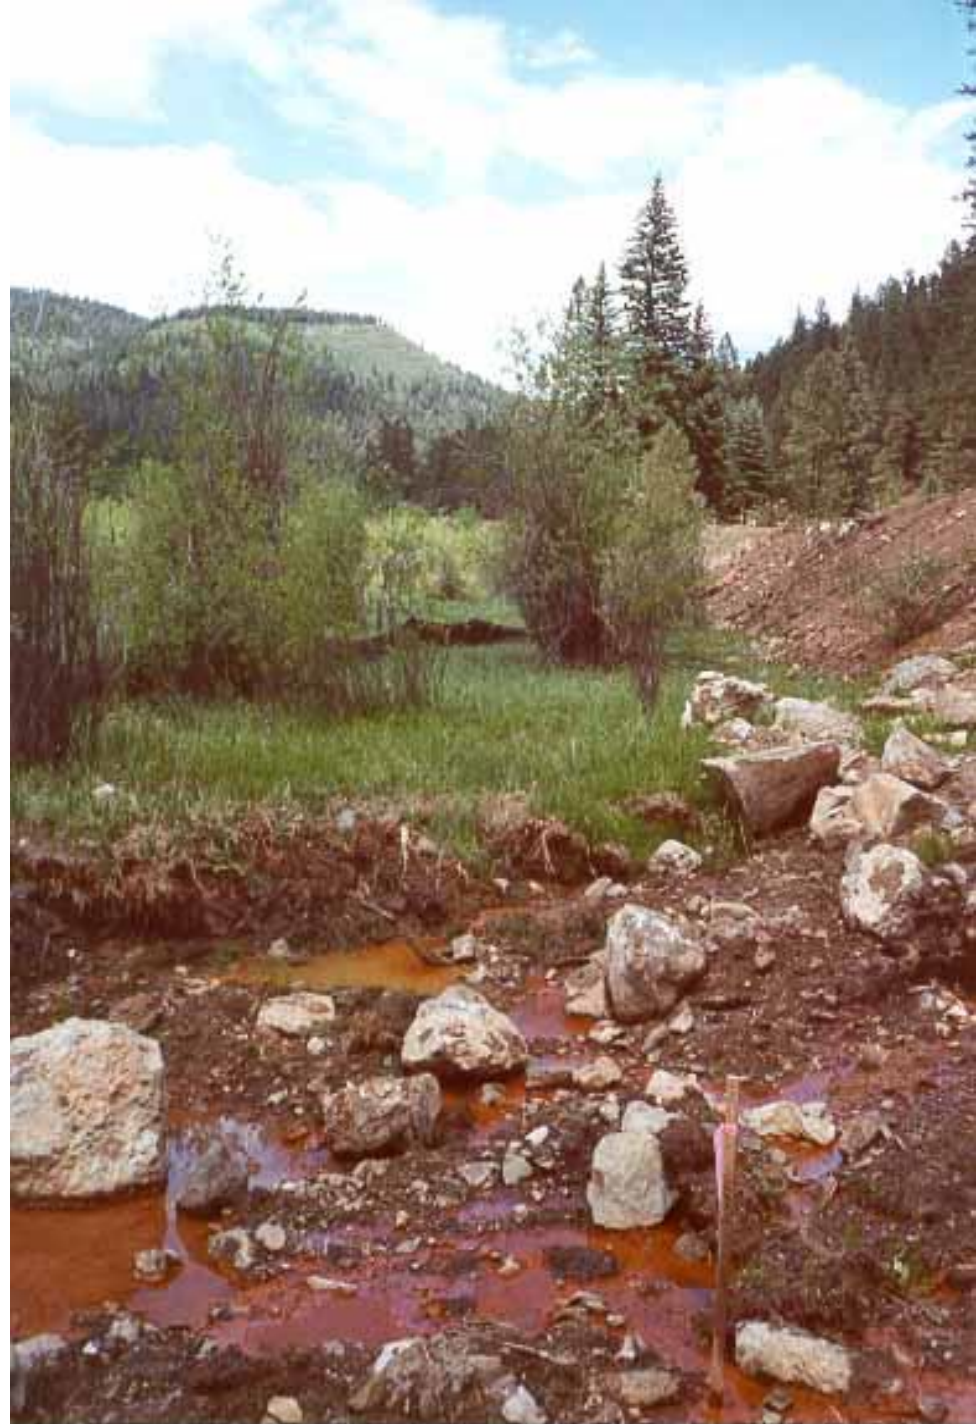
Terrero Mine Before Cleanup

- Acid rock drainage into Willow Creek
- Periodic fish kills in the Pecos River

Site	Waste Issue(s)	Corrective Actions	Authority
Terrero Mine El Molino Mill	Acid rock drainage, fish kills	Mine waste isolated and stabilized; Willow Creek reconstructed; wetlands built	State AOC
Homestake Uranium Mill	Groundwater contamination; radon in air	Tailings cover and stabilization; ground water pump and treat	Superfund
Carrizozo Gold Mill	Cyanide in groundwater	Pump and treat	Superfund
Chino and Tyrone Copper Mines	Waste ponds and tailings	Grading, capping, re-vegetation	NM Water Quality Act & Mining Act
Swastika Coal Mine	Coal gob pile	Grading, capping, re-vegetation, restore stream channel	Surface Mining Control and Reclamation Act
Cunningham Hill Gold Mine	Cyanide and cobalt in GW	Mine water treatment	NM Water Quality Act & Mining Act
Socorro Smelter	Lead in soil in residential area	Extensive soil removal	Emergency Superfund
